STAFF INVESTIGATION REPORT January 5, 2009

SUBJECT: Trees Grow Into and Short Out ComEd 345,000 Volt Transmission Line

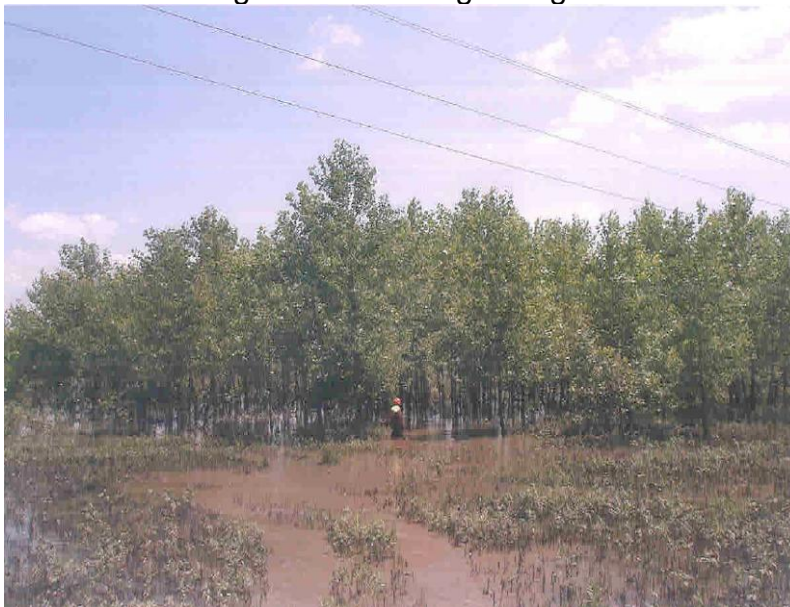
What the ComEd personnel found on that third inspection from a helicopter was a large grove of perhaps one hundred cottonwood trees growing in a swampy area beneath the transmission line on the south side of the Sangamon River (See Picture 1). ComEd crews trimmed the identified area on July 16th; the tallest trees were approximately 32 feet tall and showed seven growth rings, indicating seven years of age at the time ComEd cut them down. ComEd reported their matter to Reliability First Corporation¹¹ (RFC) on July 18th.

Picture 1: Person standing next to Trees growing below Transmission Line

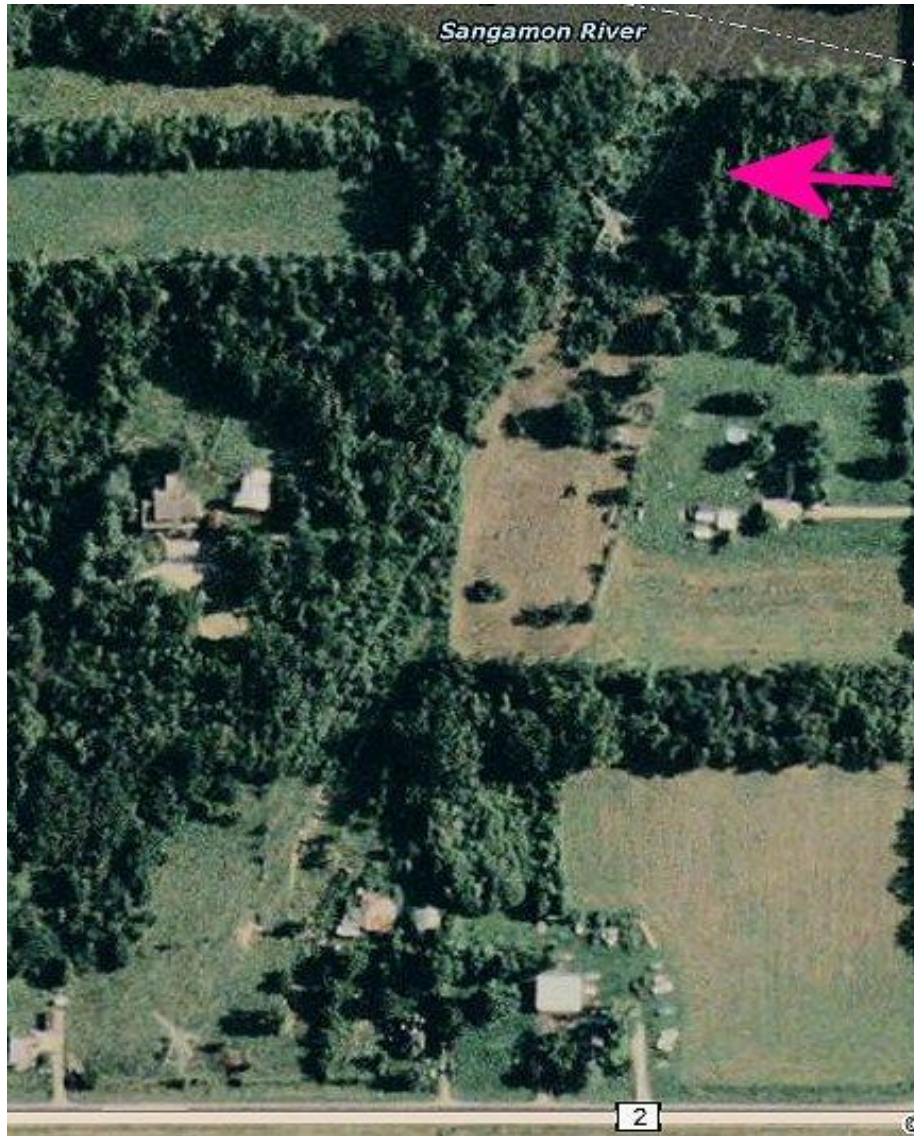
available from a number of free internet mapping services. While the date of the picture is unknown, it is recent enough (within the seven year period the trees were growing undisturbed) that the heavy growth in the 345-kV transmission right-of-way is apparent south of the Sangamon River.

Picture 2 – Aerial picture of part of transmission line pathway
